# VEHICLE INSPECTION REPORT

**KN72YDK**

## Mercedes-Benz Sprinter 315 CDI

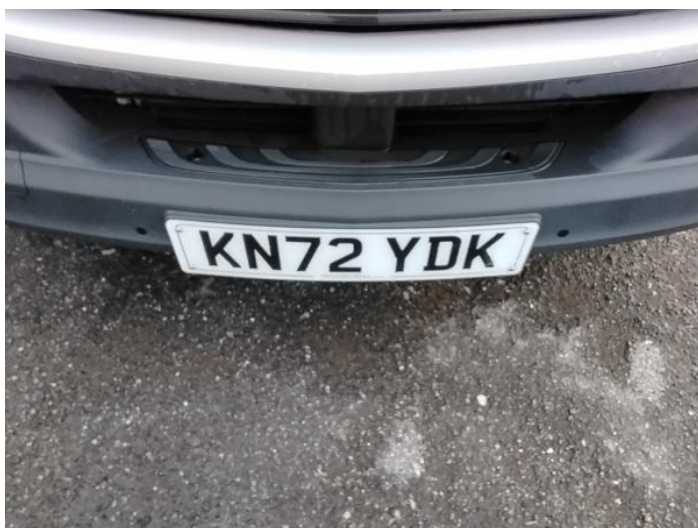
1: Number Plate Front  
Broken  
Replace

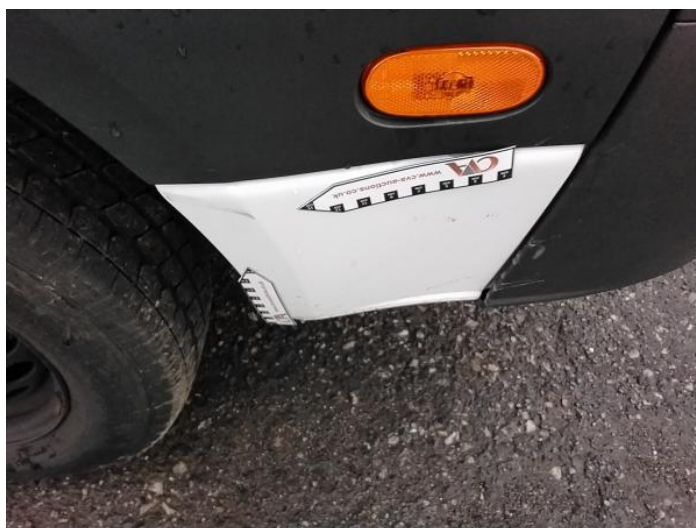
2: Qtr Panel nsr  
Dented  
With Paint Damage

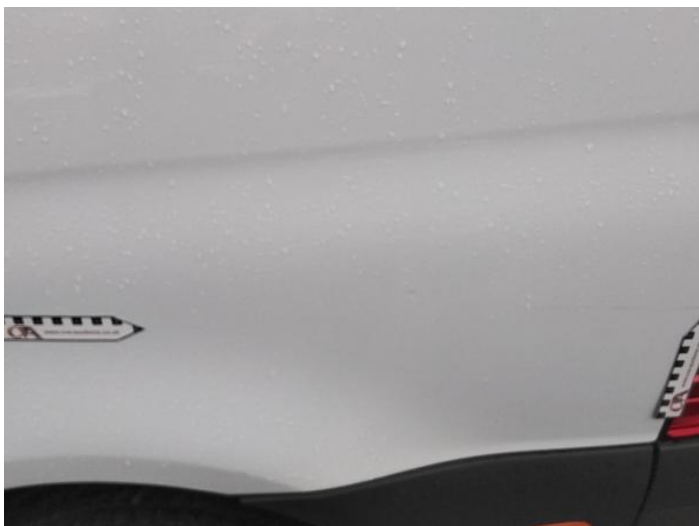
3: Qtr Panel nsr  
Scratched  
Over 25mm Thru Paint

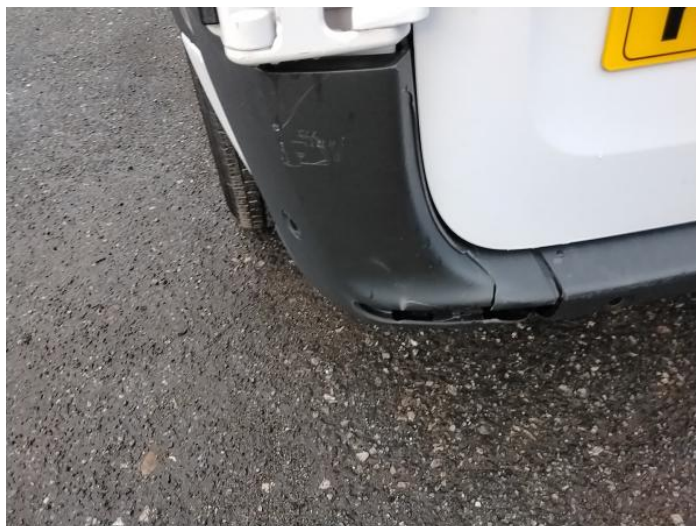
4: Bumper Rear Moulding  
Broken  
Replace

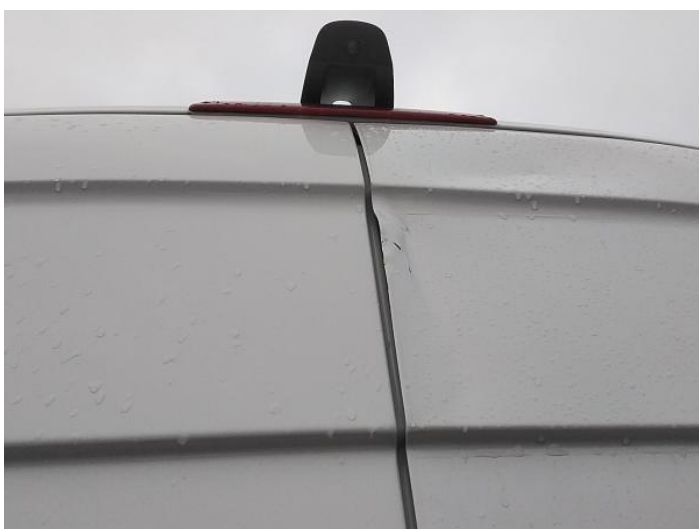
5: Door osr  
Dented  
With Paint Damage

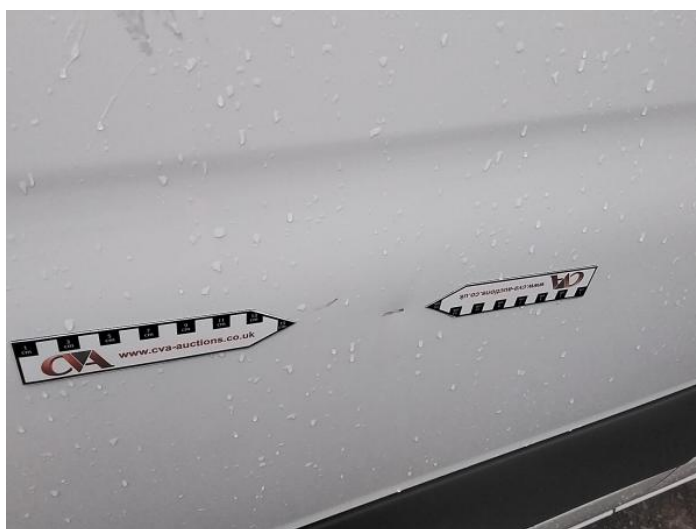
6: Qtr Panel osr  
Dented  
With Paint Damage

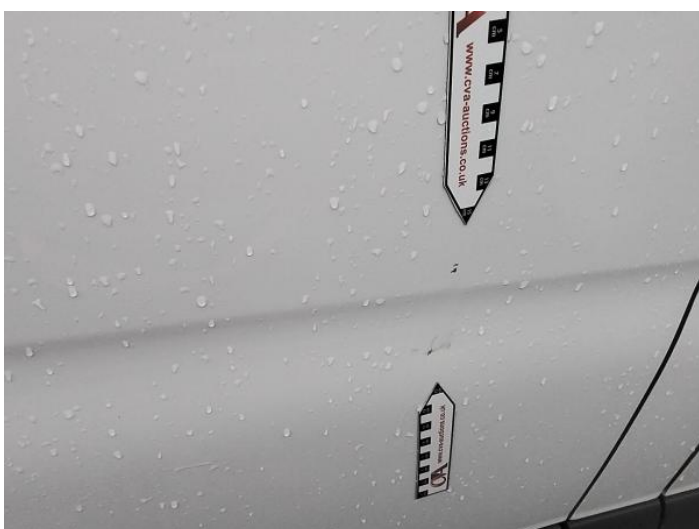
7: Qtr Panel osr  
Dented  
With Paint Damage

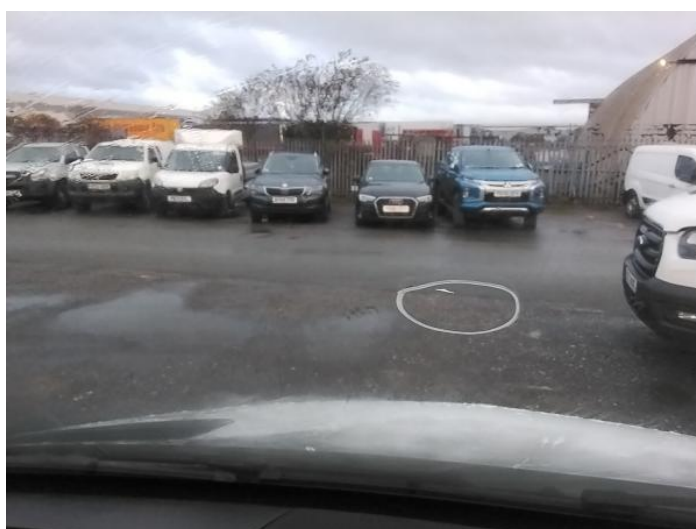
8: Screen Front  
Chipped  
Over 10mm
